**Report No. UT-04.03**

# **Annual Experimental Features Report**

***Utah Department of Transportation Research  
Division***

***June 2004***

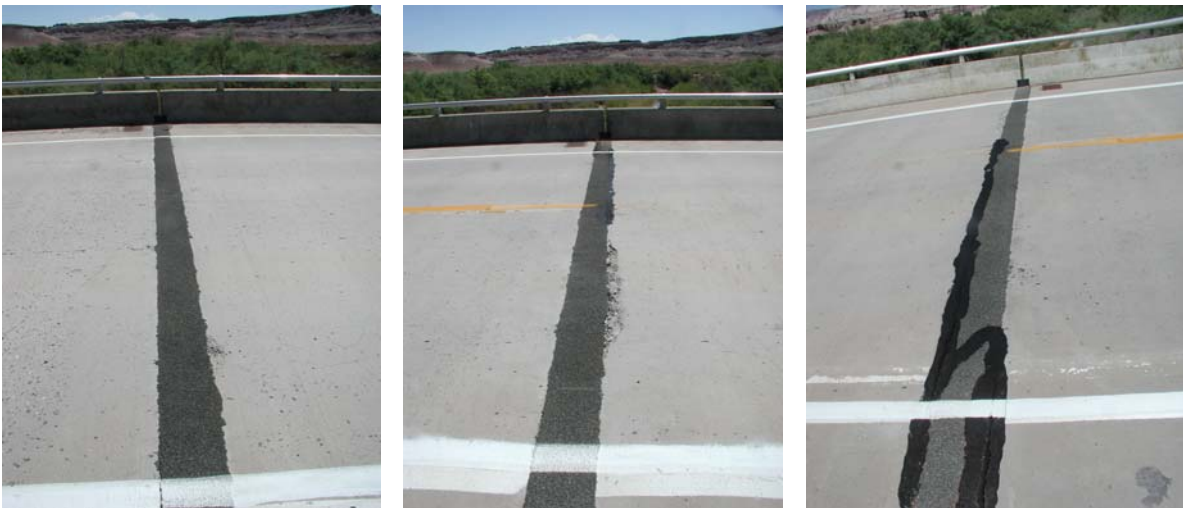
Figure 12- Pictures of all 3 joints.

The product was placed in April 2001. Research visited the test site on September 2, 2002. The condition of the experimental material was good. The material showed slight signs of cracking and spalling. However, the concrete adjacent to the product was beginning to spall (See Appendix).

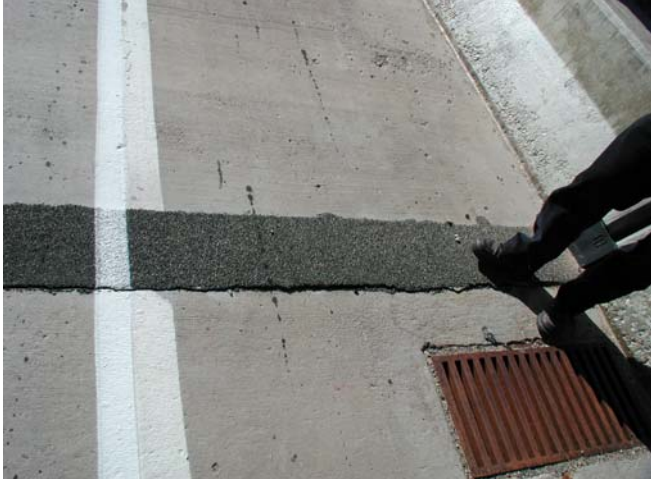
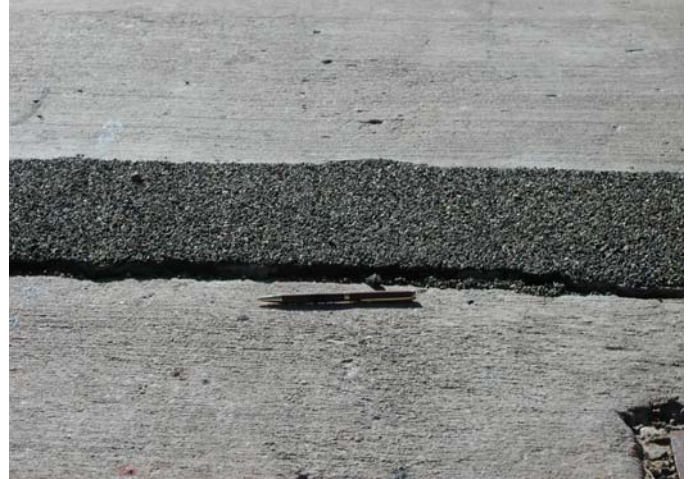
Illustrations of the material “squeezing” out of the joint due to thermal expansion

Ure-Fast PF-60 should not be used in the future to replace expansion joints on bridges that have at least as much expansion as this bridge. The material may work alone in another location where the bridge does not expand as much as this bridge.

Ure-Fast PF-60 can and should be used with the Ure-Fast liquid sealant to replace the joint (See Appendix). Other states have had success with this combination.

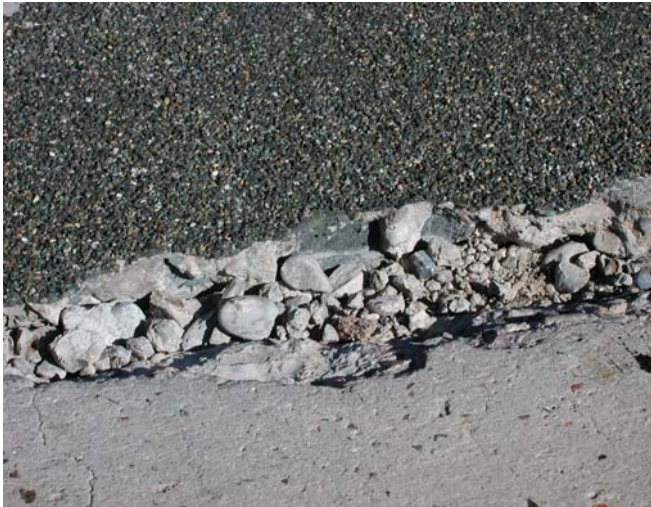
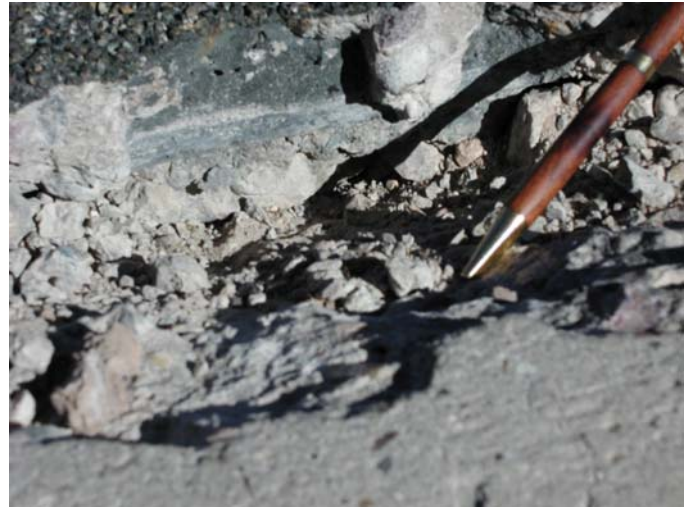
The opinion of UDOT Research is that the expansion of the bridge deck had transferred through the product and caused the concrete on either side of the product to fail in compression. It appeared as though the compressive strength of the product exceeded that of the concrete. The Structures Division Inspectors rated the condition of the bridge deck as “satisfactory” on an excellent to poor scale (the condition of the bridge deck was “bad” in the opinion of the evaluators). This may have contributed to the spalling in the concrete.

Illustrations of the adjacent concrete spalling

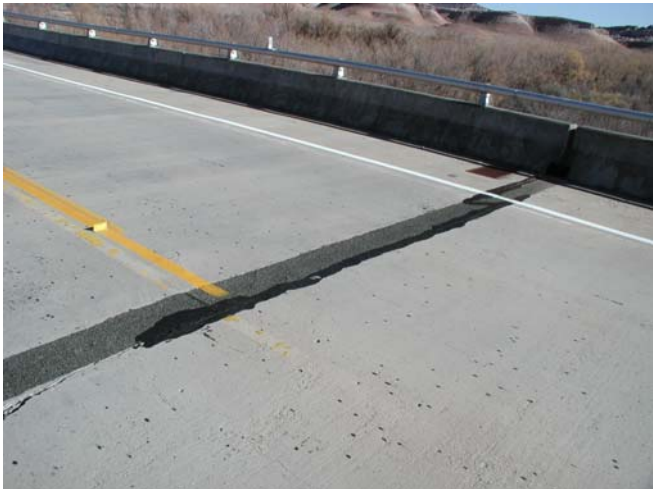
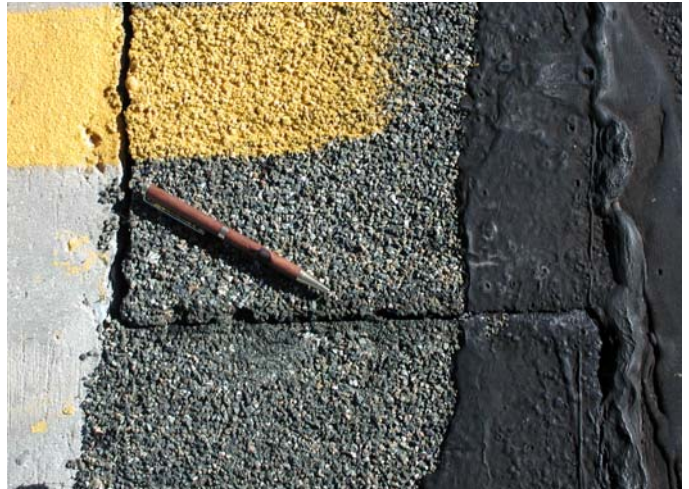
Notice one section is raised and the other is not. Maintenance crews have sealed the lip for snowplow operations

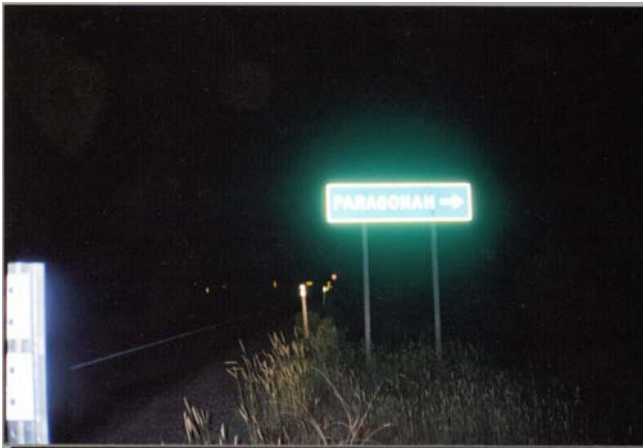
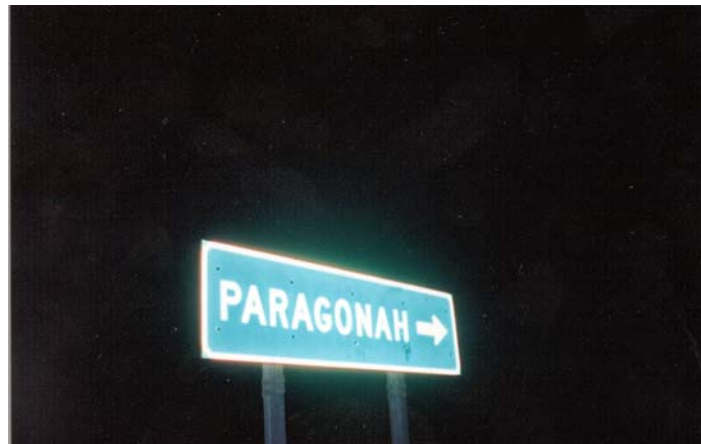
**Figure 5- Sign shows no durability concerns.**

There does not appear to be any difference between the part of the sign that was lightly sanded and the side that was not. There do not appear to be any noticeable defects in the durability of the product.

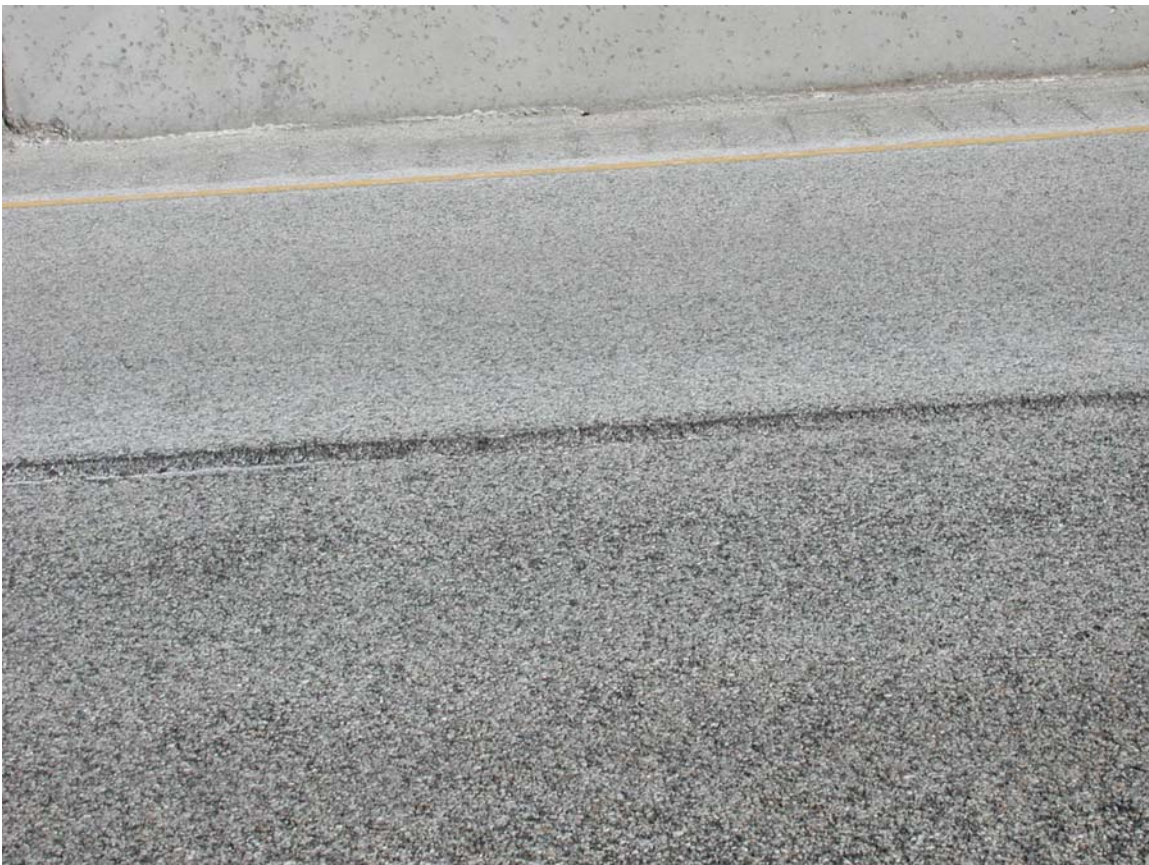
In some sections of the thermoplastic region, the asphalt overlay and the thermoplastic material were removed during the winter. The asphalt was only removed directly under the thermoplastic leading to the thought the thermoplastic material may have negatively affected the underlying asphalt. See Figure 1.

Figure 5- Localized removal of asphalt under thermoplastic material.

This location may require a groove into the asphalt. This location experiences a high number of trucks, and has an AADT of about 15,000. The road at this location has a lot of curves, which is harsh on skip lines. These materials may need to be placed on the edgelines instead to see if it is the conditions or the material that is the cause of failure. It is evident that waterborne and thermoplastic should not be used on the skip line of this section since the durability was so low. Epoxy and MMA will give daytime presence, but will not be visible at night.

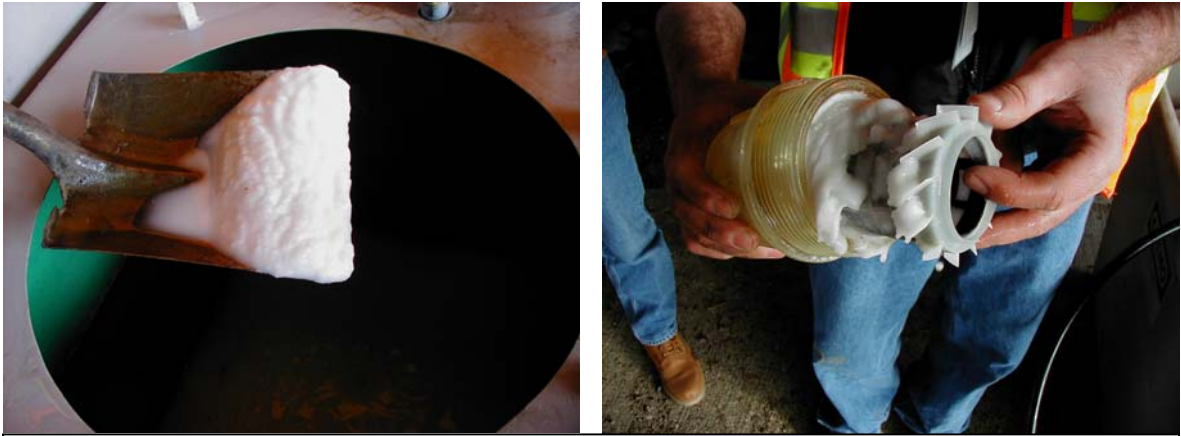
was sprayed onto the road. The Boschung people had to come and clean every valve on the system requiring traffic control to be set up under the SPUI for a second time.

**Figure 5- Precipitate formed by mixing KAc with MgCl**

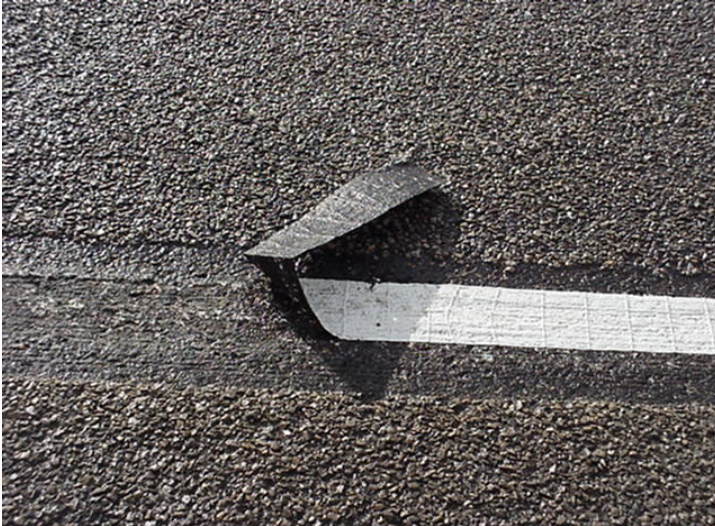
Figure 5-Failed tape on SR-6

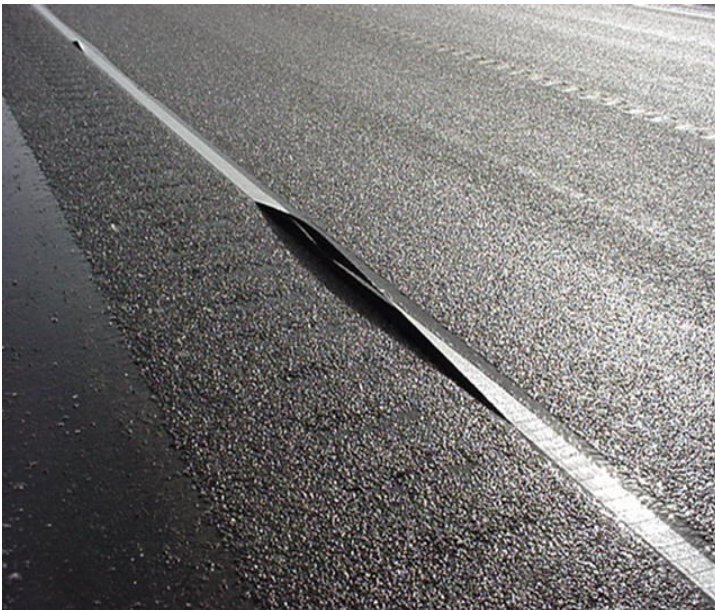
Figure 5-Failed tape on SR-6

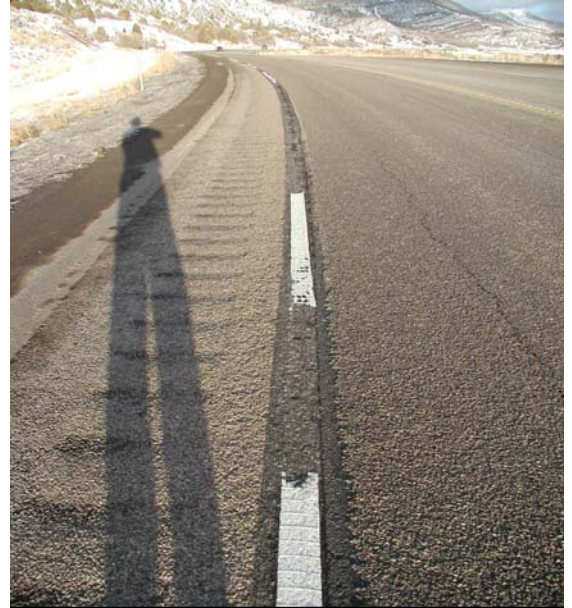
Figure 5-Failed tape on SR-6

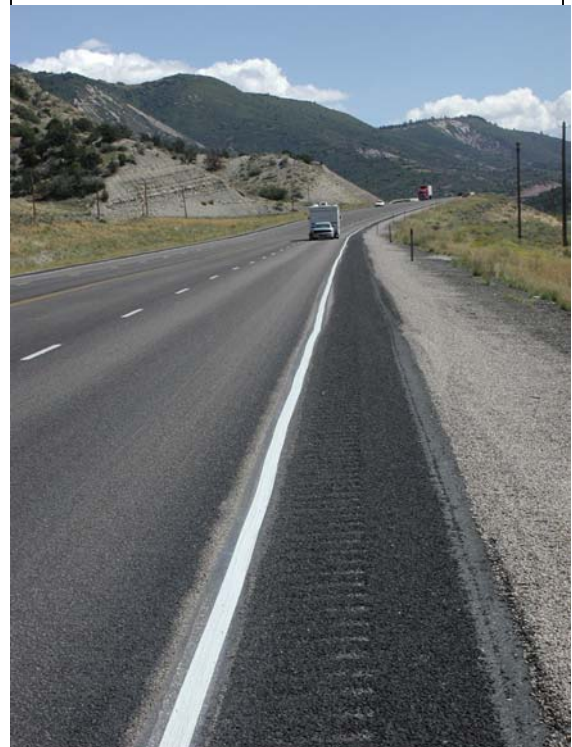
Figure 5-90% typical tape on SR-6

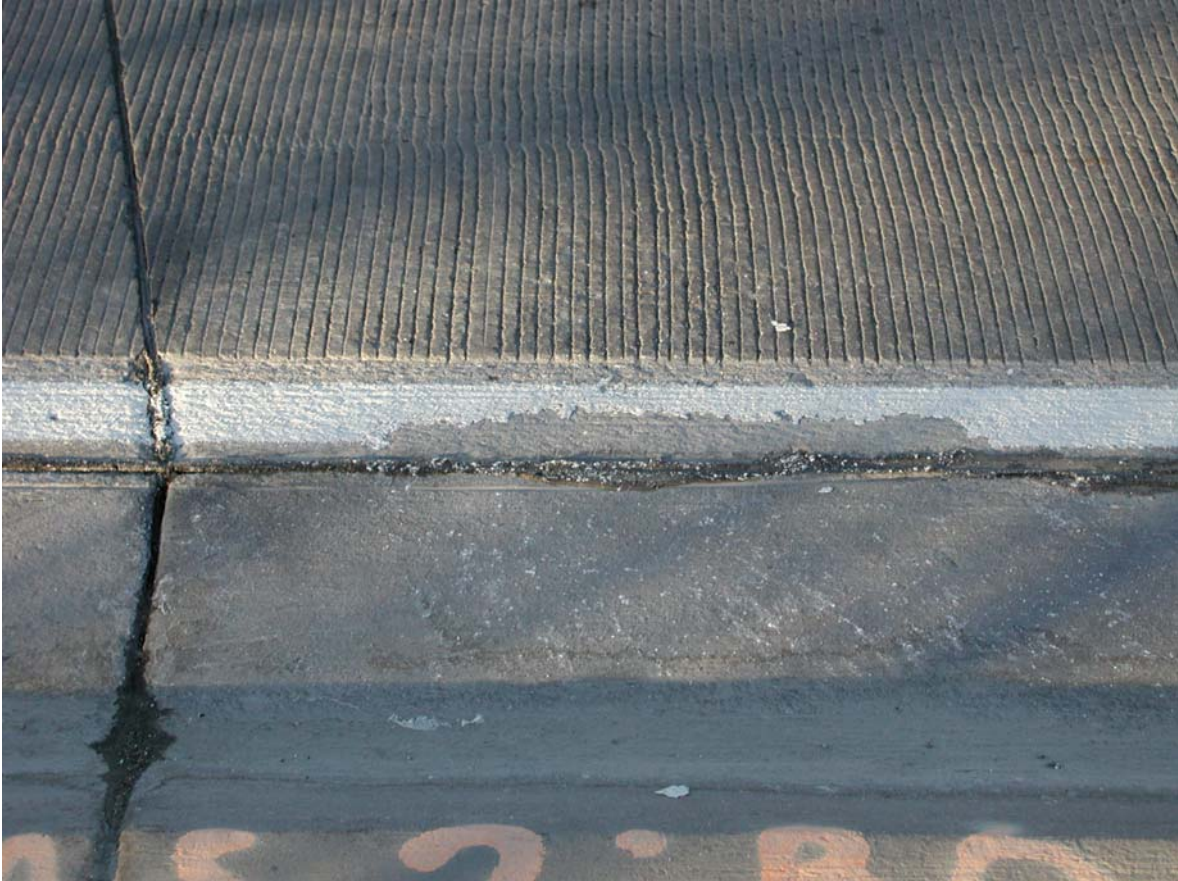
Second, the product is exceptionally sensitive to water or other contaminants present on the pavement surface at application. There was a place on the project where water began pumping out of the pavement joints as the paint truck passed. The applied material immediately debonded from the concrete surface. Figure-1 shows the result.

**Figure 6-Debonded material due to pumping problem**

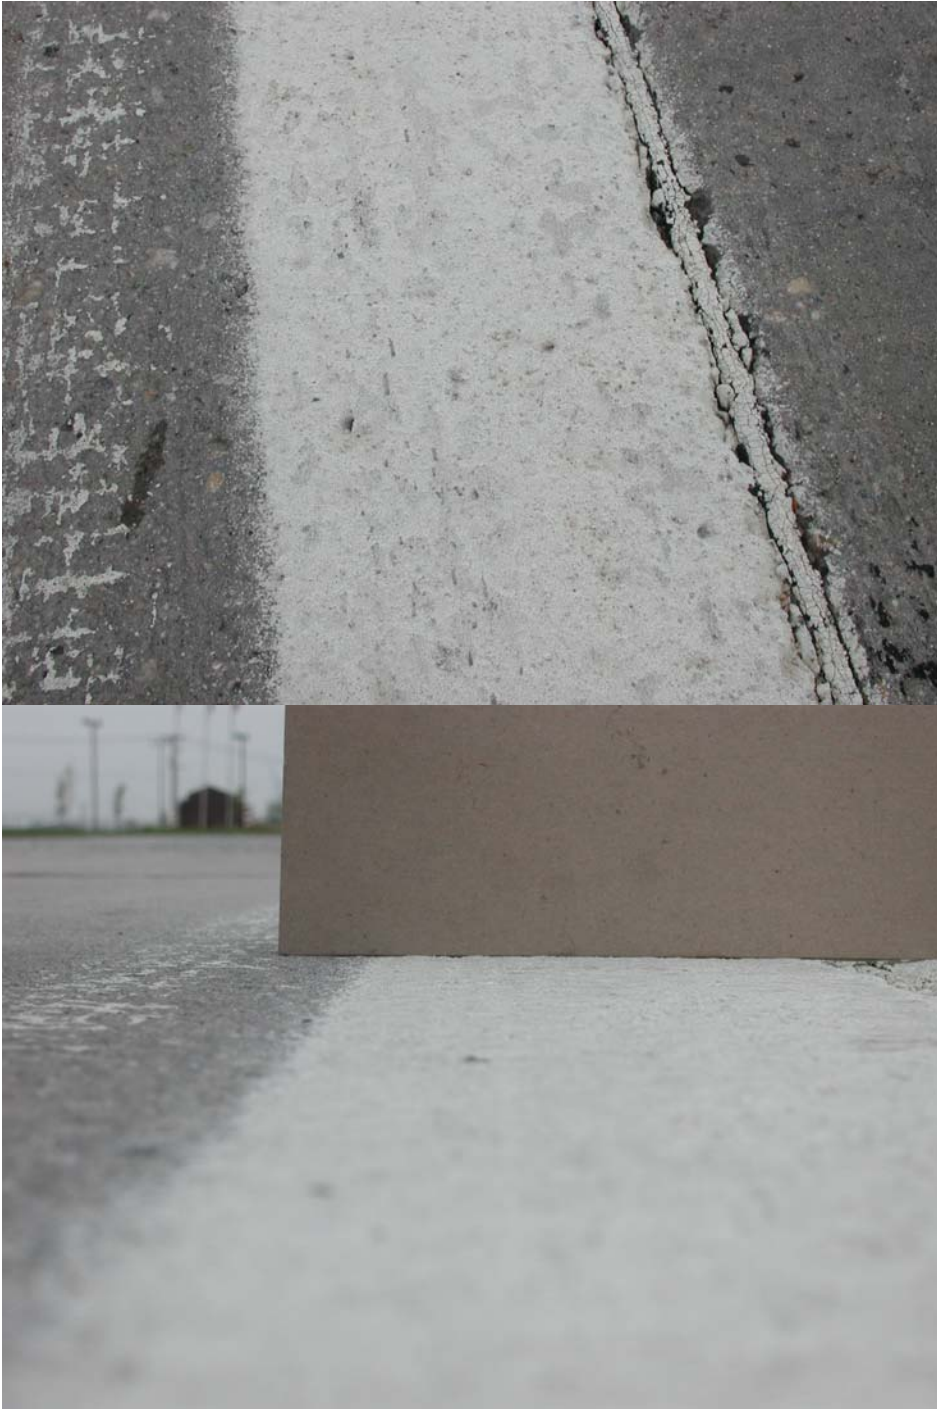
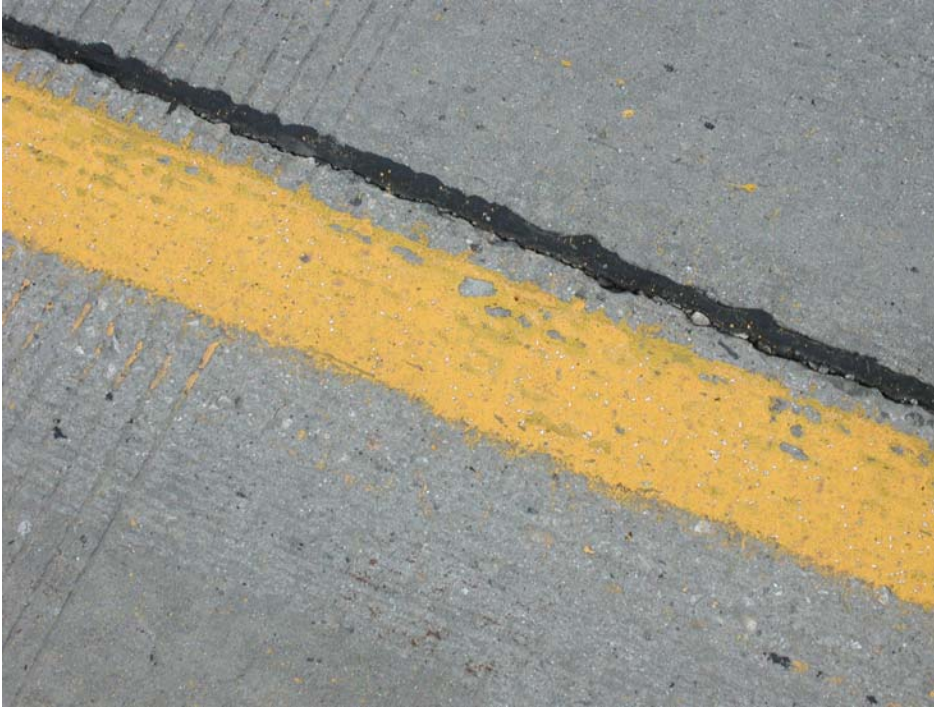
The standard deviation of the product has increased dramatically through one plow season. Observations conclude this is probably due to the variance in inlay depth. As mentioned earlier, the contractor did not plan on inlaying this product. Therefore, he did not take care to make sure the inlay depth was consistent. It is evident at places where RR values are low that the material is being ground off, probably by snowplows (see figures below).

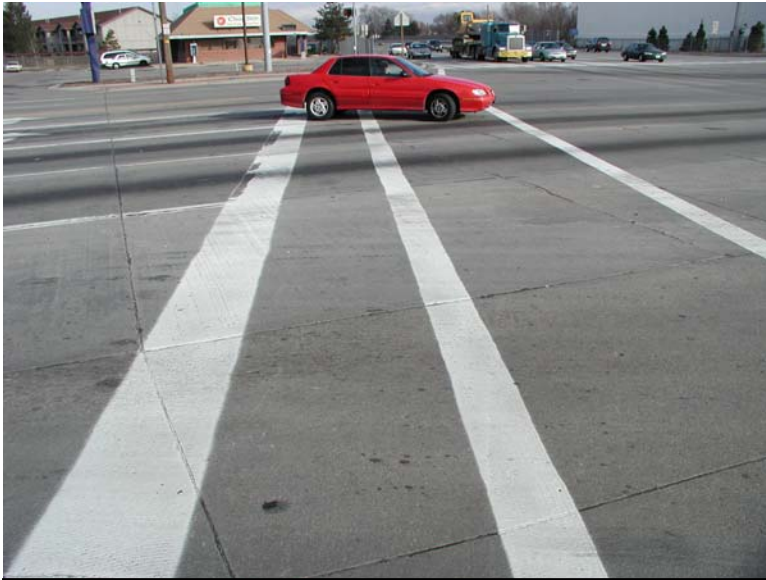
**Figure 6- Middle of 1st Season (1/28/03)- Shows oil drip locations**

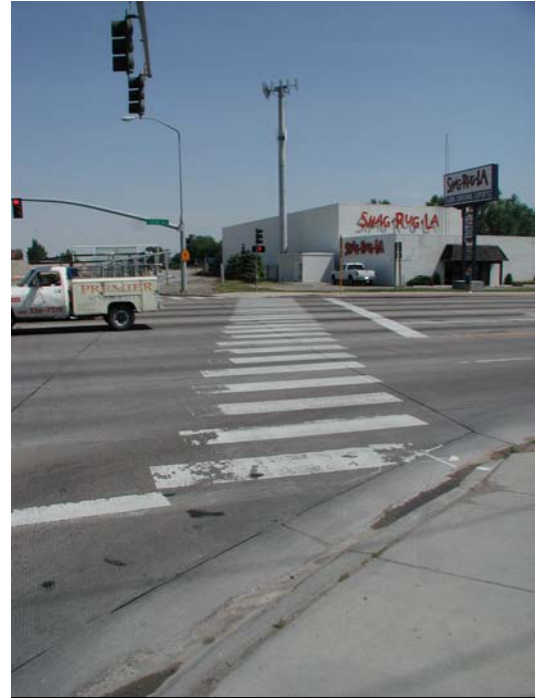
**Figure 2- After 1st Season (6/27/03)- Notice that the stop bars is in good shape while tips of markings are gone.**

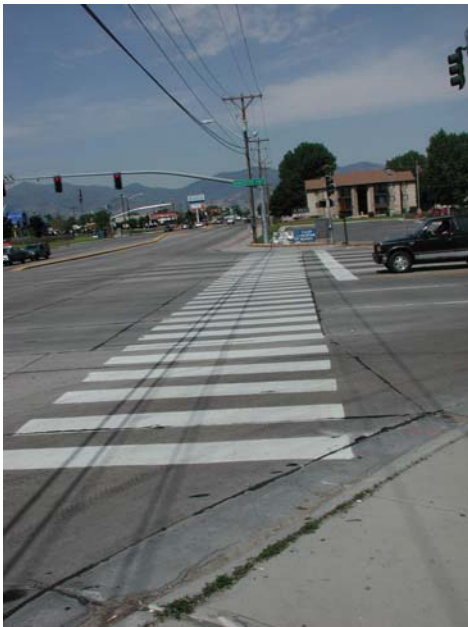
**Figure 3- (6/27/03)- Typical picture after 1st Season**

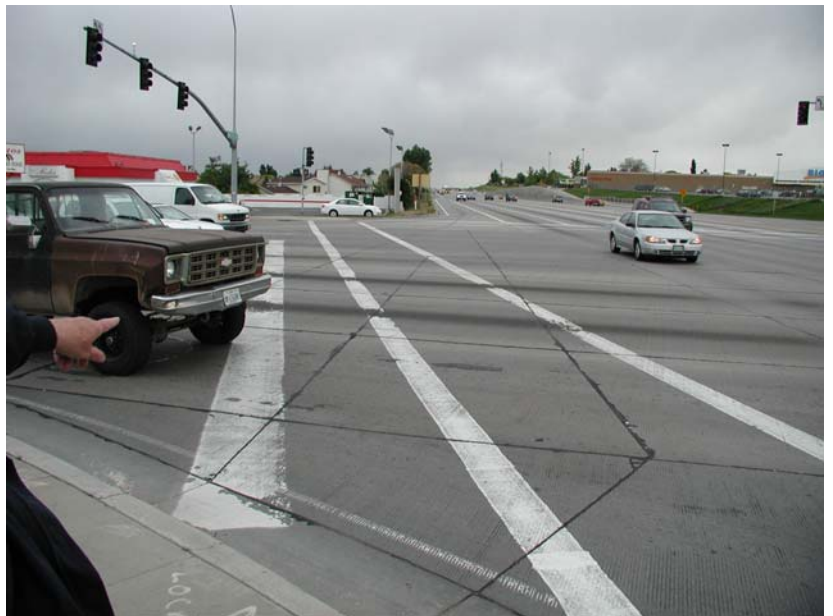
**Figure 4- After 2nd Season (5/24/04)- The marking shows the 1<sup>st</sup> signs of wear. Until this point, there were problem areas, but most areas showed no signs of wear.**
